ANNUAL REPORT FOR 2003

Little Sugar Creek Mitigation Site

Mecklenburg County

Project No. 8.U670122

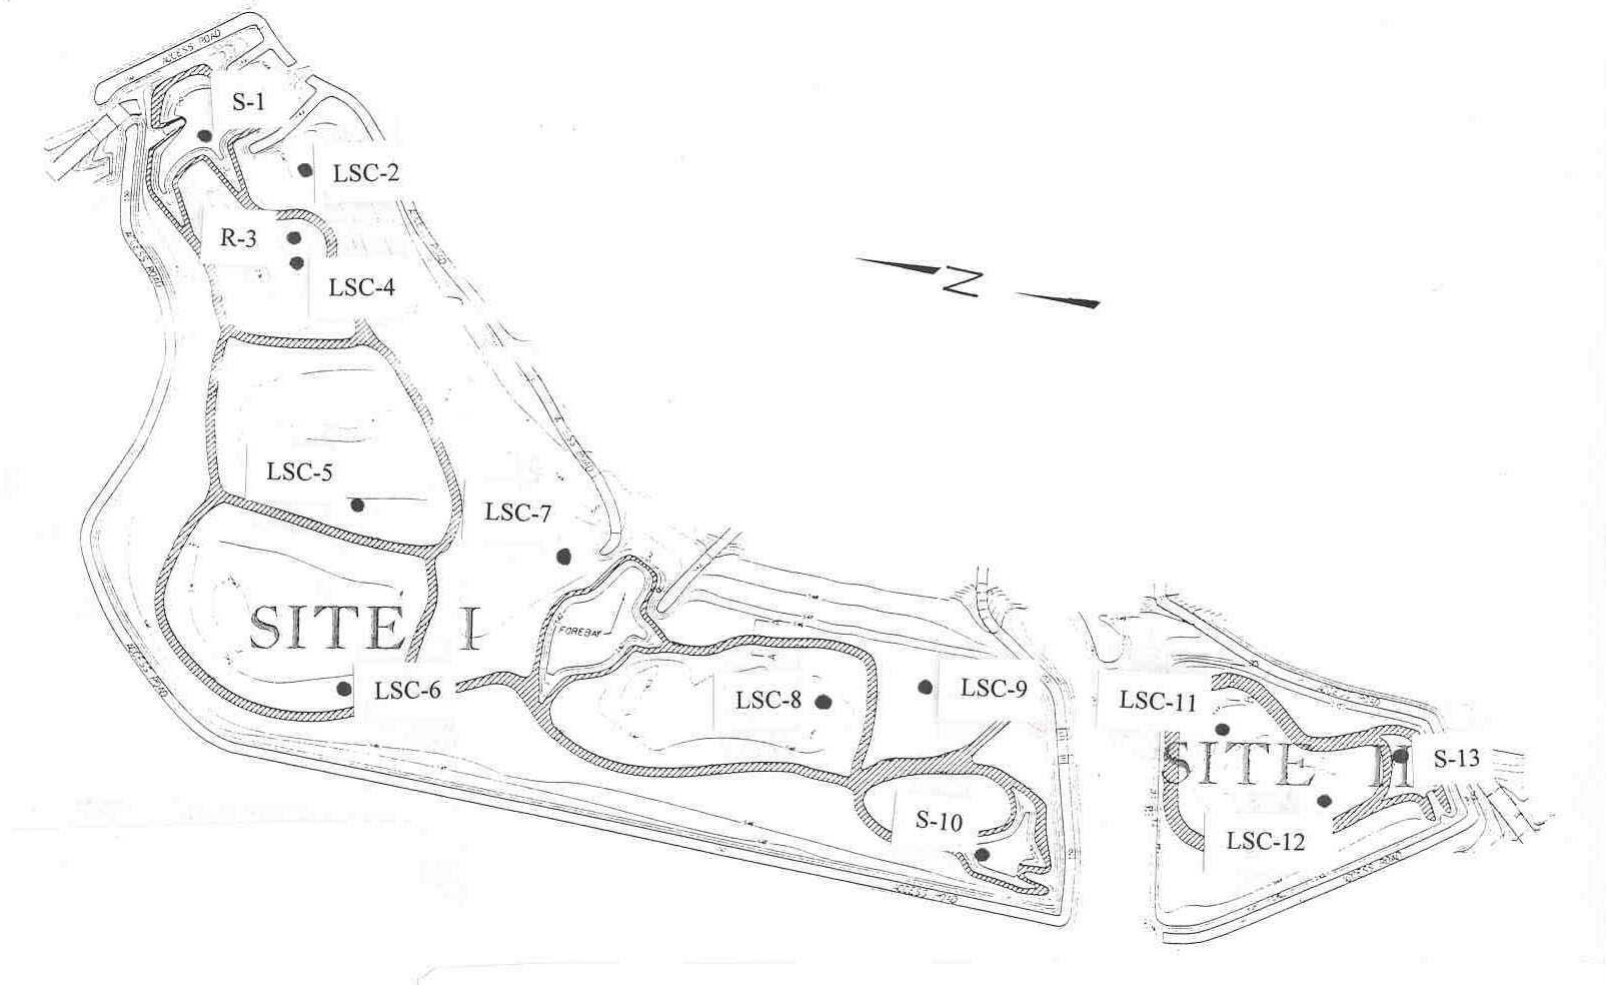
Figure 2. Gauge Location and Site Modification Map

Nine groundwater gauges, one rain gauge, and three 80-inch surface water gauges were installed in 1997 (Figure 2). The automatic monitoring gauges record daily readings of the groundwater depth.

The sluice gates, which were closed in July 1999 to hold surface water on the site, remained closed in 2003. In an attempt to further augment the site hydrology, the weir was raised approximately eight inches in the ditch where the sheet piles are located and clay was added to the face of the rip-rap at the emergency spillway in 2001. The elevation of both emergency spillway outlets was raised to match the elevation of the flood control structure in March 2002.

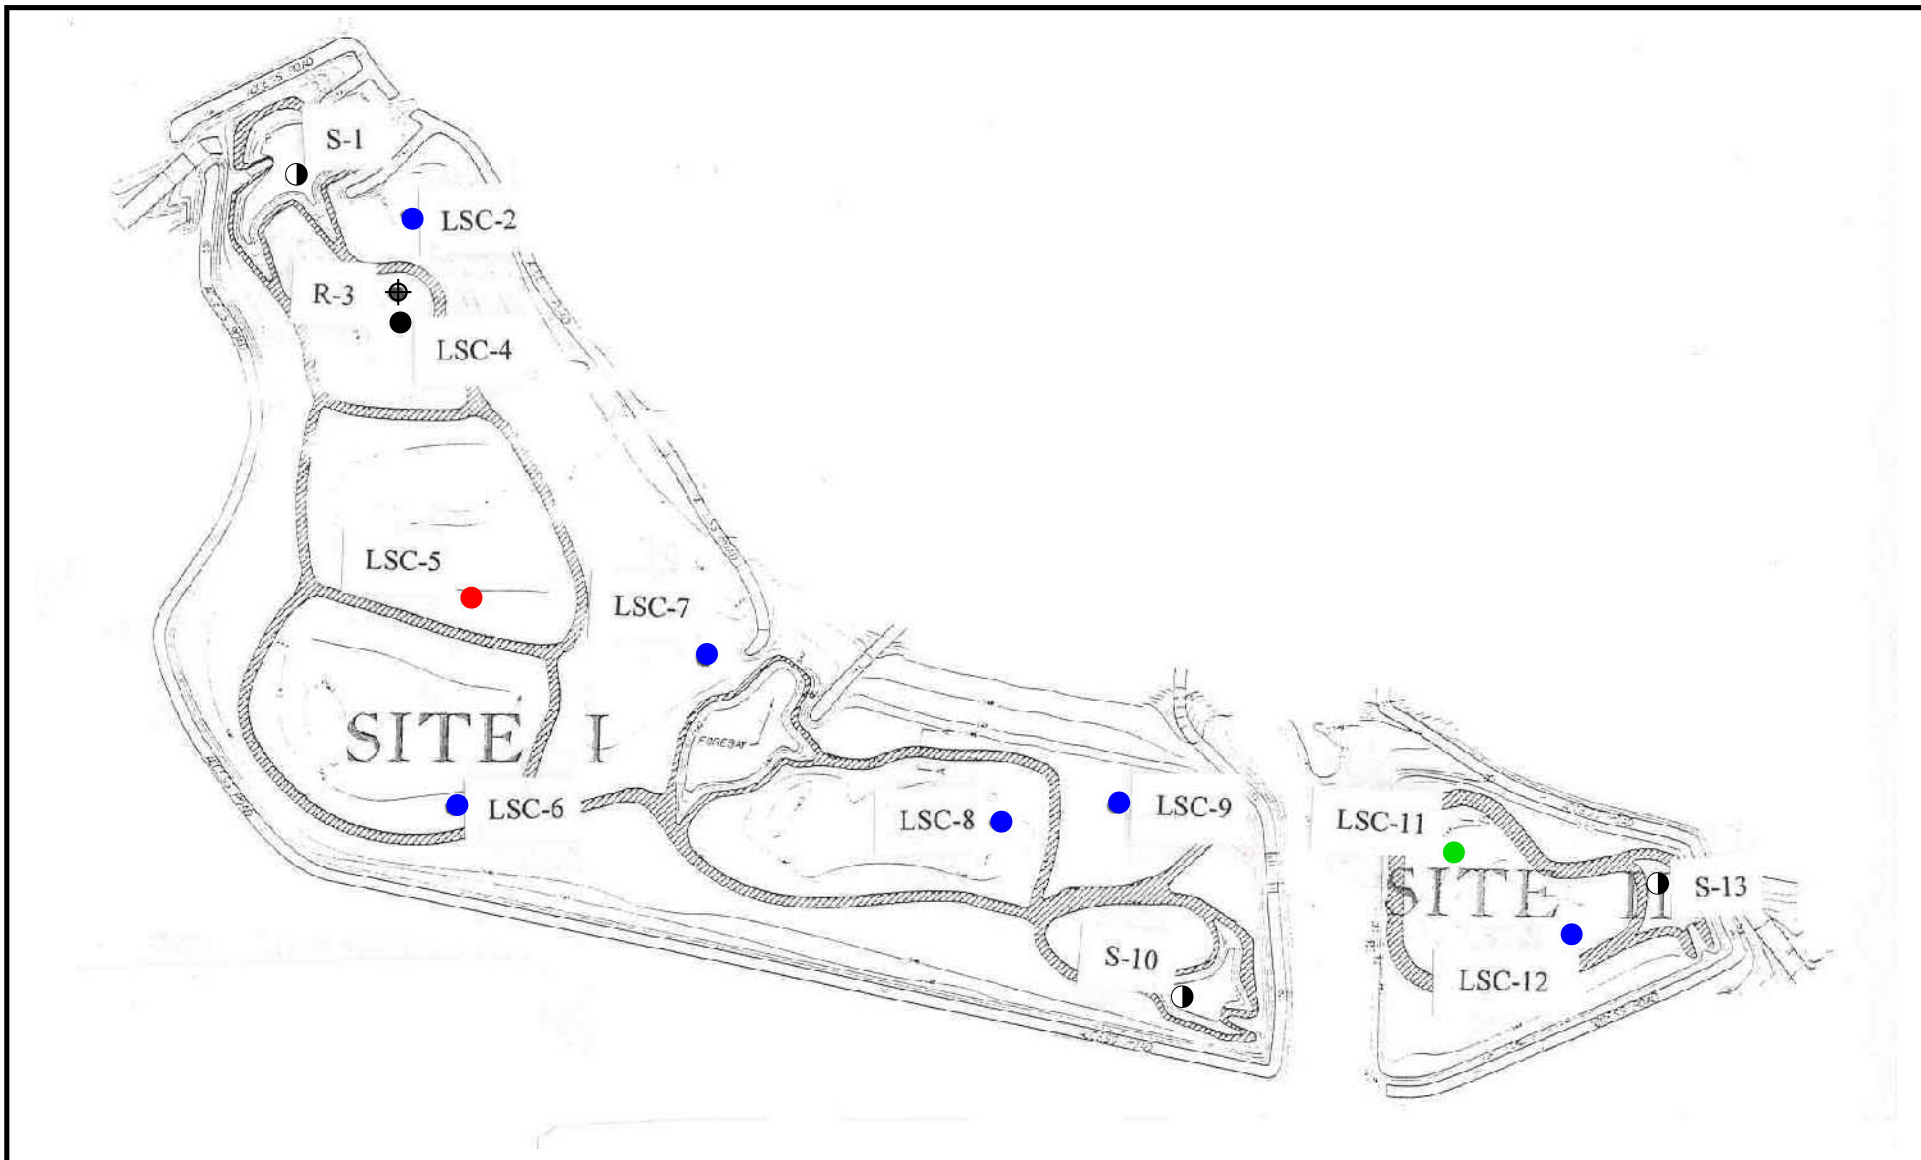
Figure 3. 2003 Hydrologic Monitoring Gauge Results

The placement of the groundwater gauges and a graphical representation of the hydrologic monitoring results are provided in Figure 3.

Monitoring Gauge	< 5%	5-8%	8-12.5%	> 12.5%	Actual %	Dates of Success
LSC-2				✕	39.6	April 17-July 18 July 30-Aug 28
LSC-4	✕				0.9	
LSC-5			✕		10.6	Aug 4-Aug 28
LSC-6				✕	41.7	March 22-June 27
LSC-7				✕	40.9	March 22-June 25
LSC-8				✕	14.0	July 30-August 31
LSC-9				✕	19.1	June 7-July 21 July 30-August 30
LSC-11		✕			7.7	
LSC-12				✕	17.0	March 22-April 30

- Gauge 4 did not record data from January to July 17 or August 26 to November 13 due to battery failure and gauge replacement.
- Gauges 2, 5, 8, 9 were not downloaded during the beginning of the growing season due to the depth of inundation around the gauges.
- Gauge 5 had a battery failure June 7 to July 17.

During the 2003-monitoring year, six of the nine gauges met the jurisdictional hydrology (saturation for 12.5% of the growing season). Two of the nine gauges that did not meet success experienced malfunctions, early in the growing season. The surface water gauges indicated persistent surface water in the channels throughout the growing season.

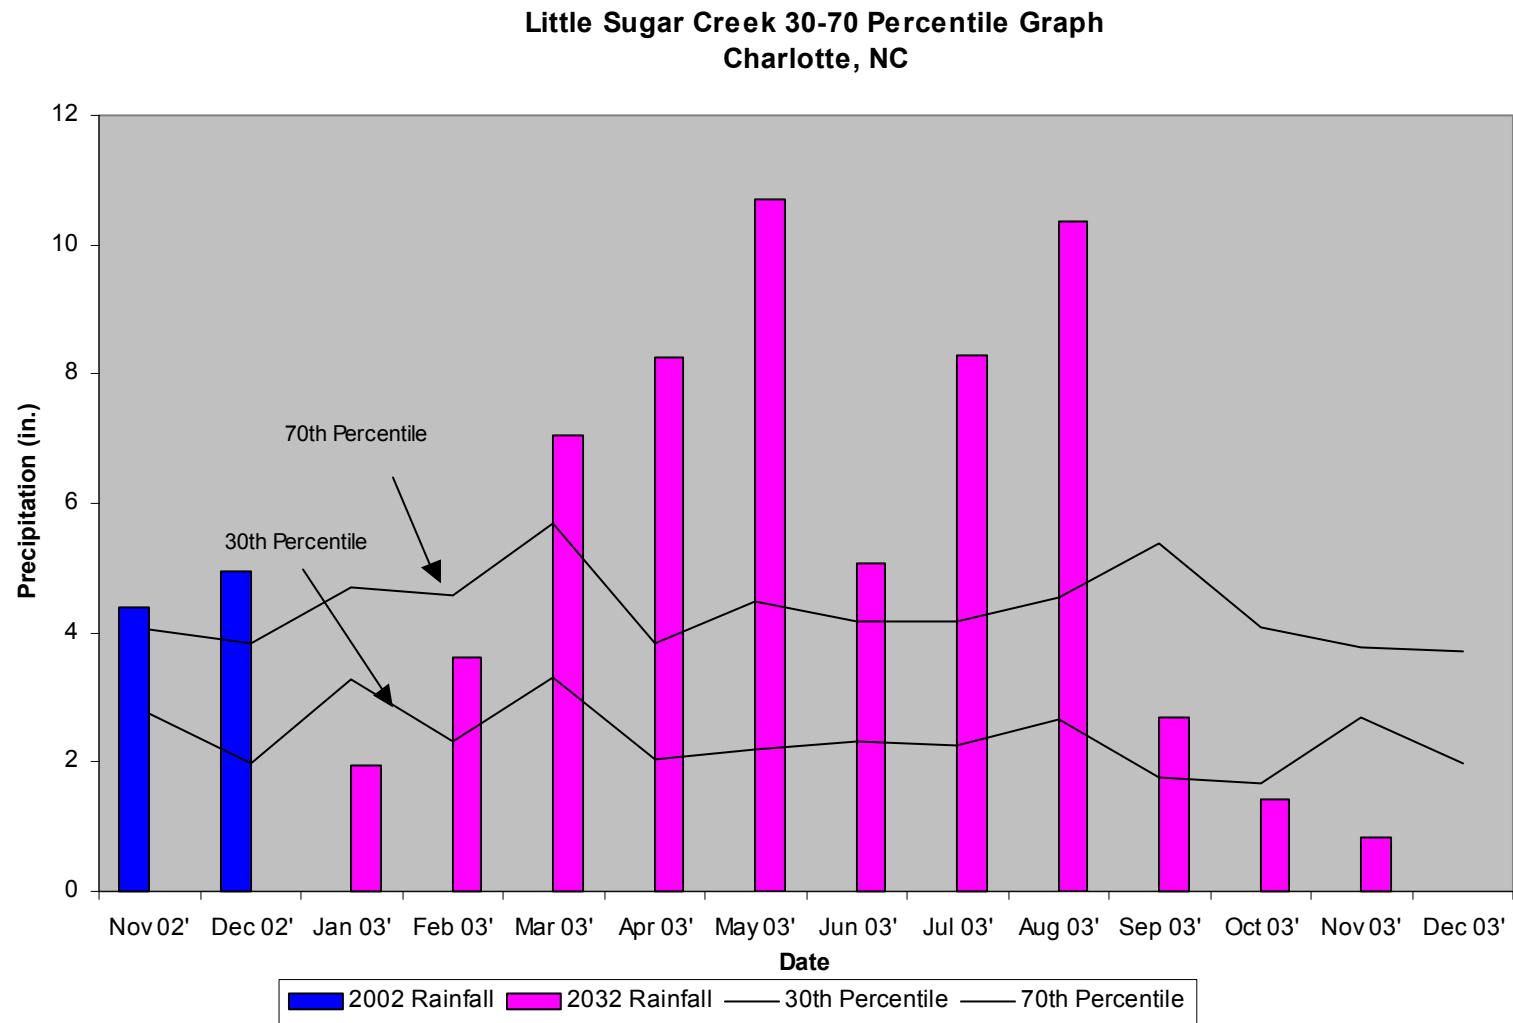
Figure 4. 30-70 Percentile Graph

Figure 4 is a comparison of 2002 and 2003 monthly rainfall to historical precipitation for the area. This comparison indicates if 2003 was “average” in terms of climate conditions by comparing the rainfall to that of historical rainfall (data collected between 1972 and 2003). The NC State Climate Office provided all historical data.

For the 2003-year, November (02'), December (02'), March, April, May, June, July, and August experienced above average rainfall. The months of January, October, and November recorded below average rainfall for the site. February and September experienced average rainfall. Overall, 2003 experienced an average to above average rainfall year.
